## MONITORING OF AN ARTIFICIAL TURF FOOTBALL PITCH

Assessment of risk management  
measures to prevent the release of  
microplastics

February 2023

**SIGNUS**

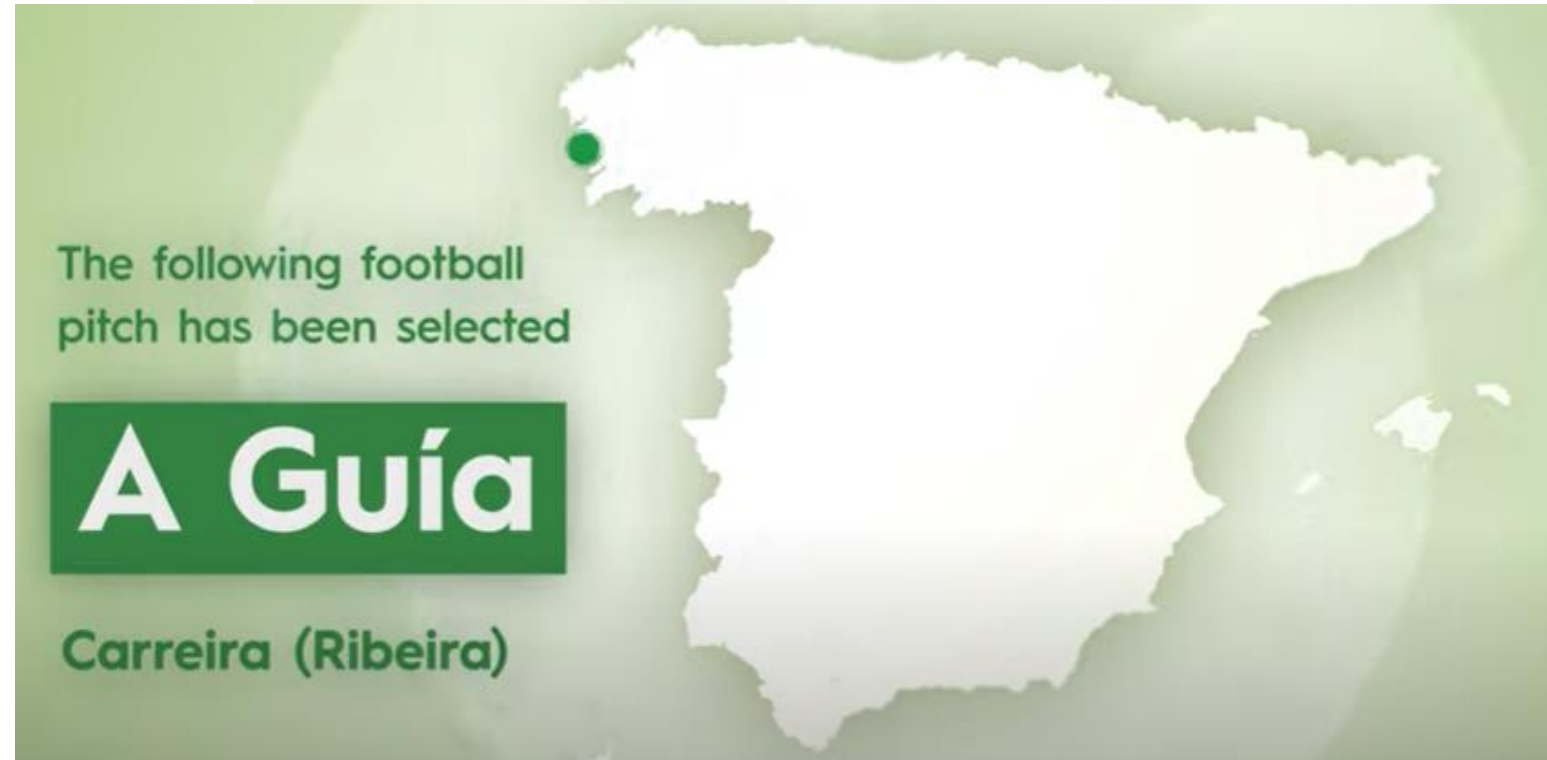
- Federated 11-a-side football pitch
- Surface of 5,680 m<sup>2</sup>
- Built in 2017
- Located on the north-west coast of Spain

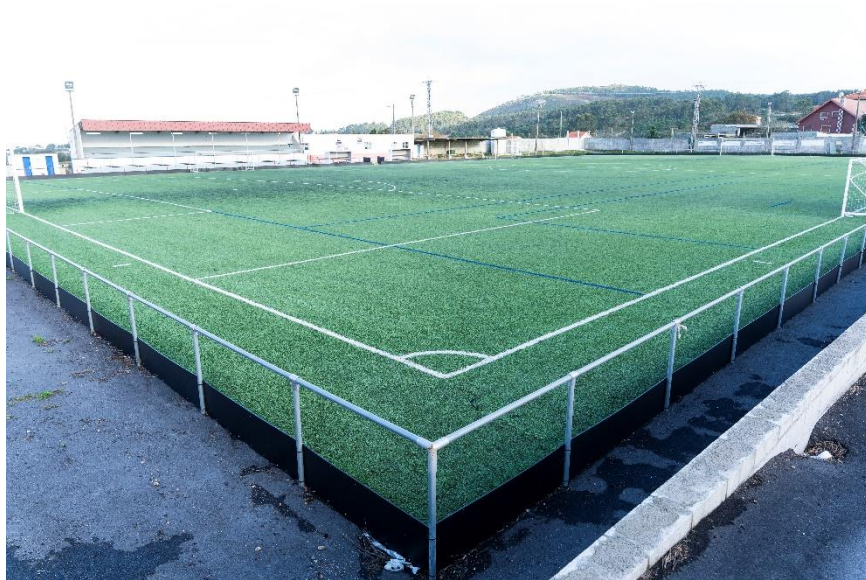
*Fencing panels*

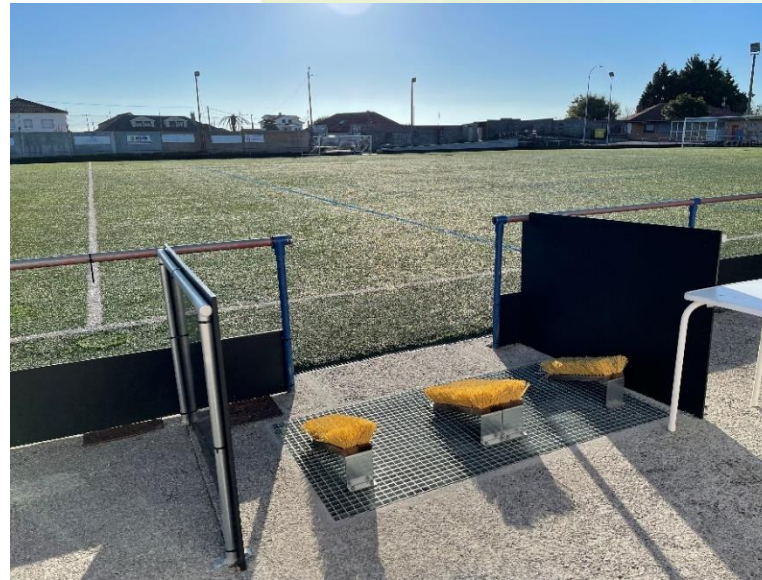
*Brushing station*

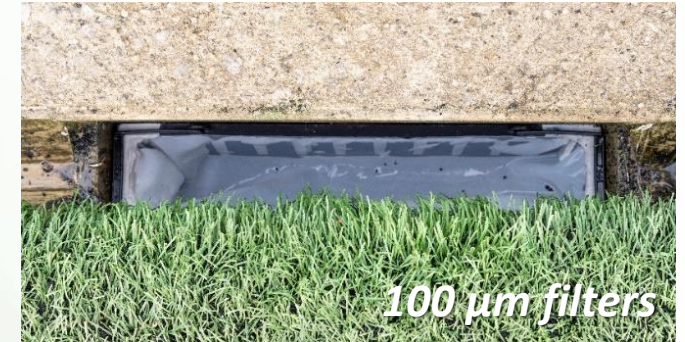
*Filter system in the pitch  
water drainage*

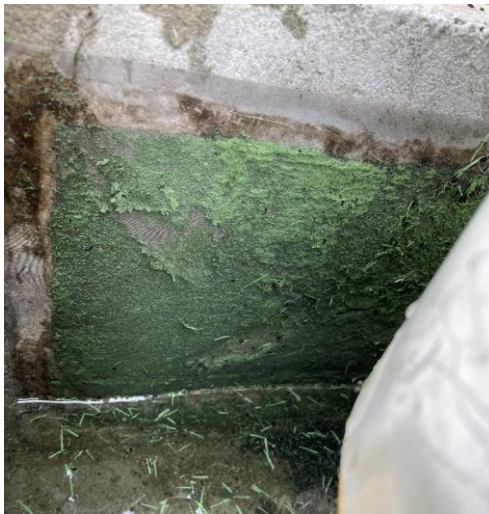
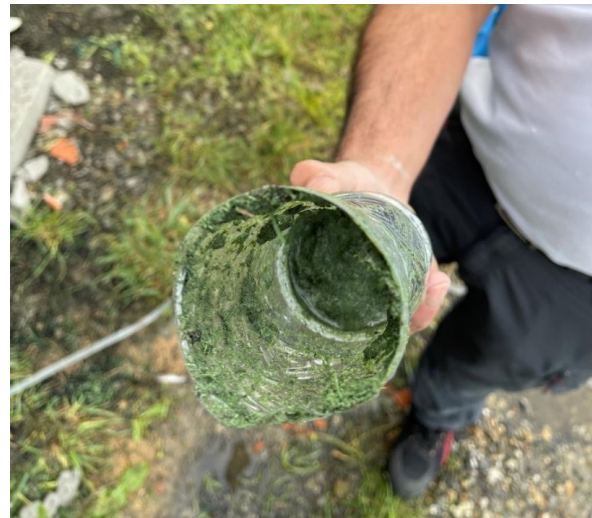
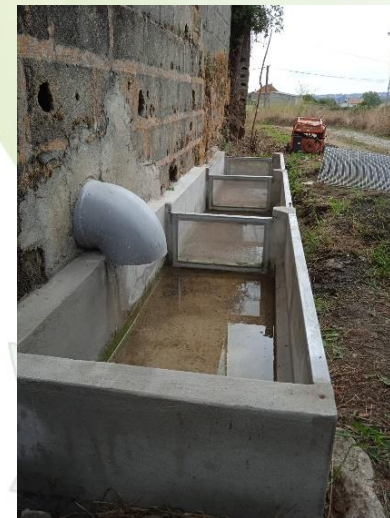
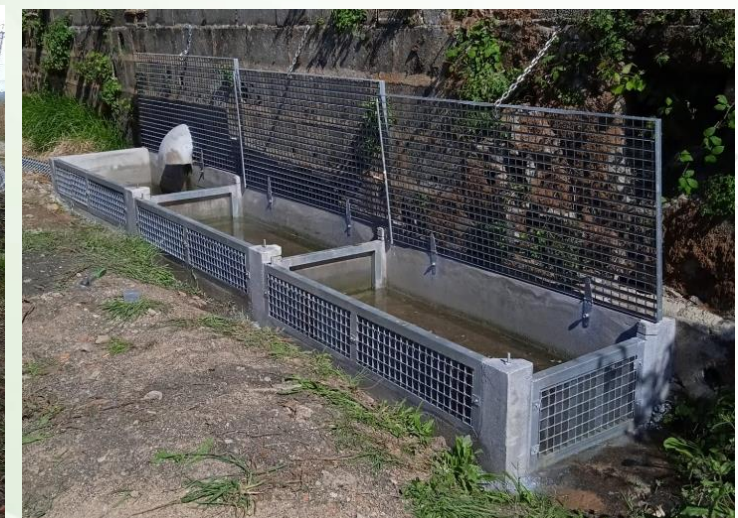
## ***INCIDENT:*** Identification of a new source of microplastics

Filters clogged in the general drainage, mainly due to free fibres arising from the wear of the artificial turf.

New design of the system in the general drainage, increasing its drainage capacity.

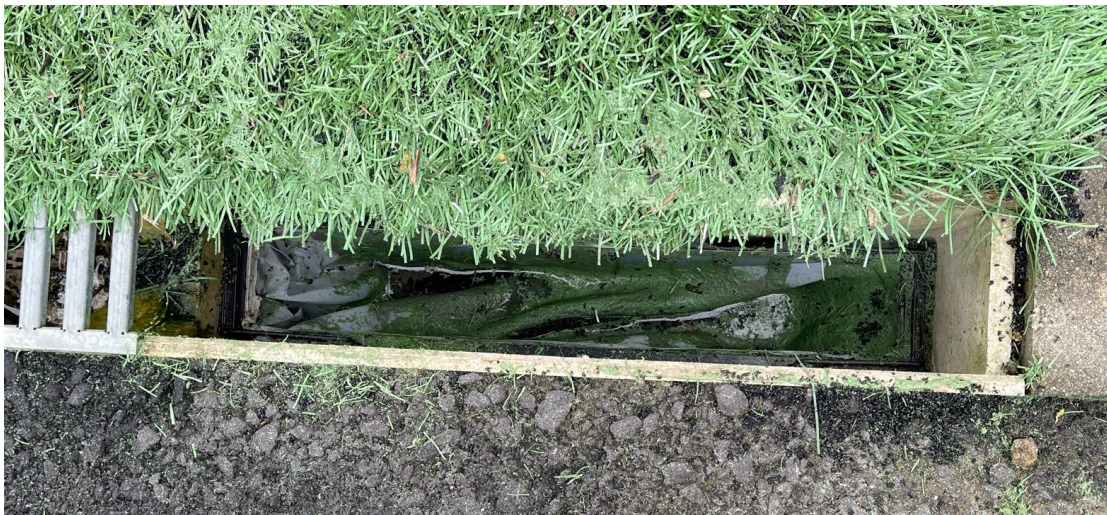
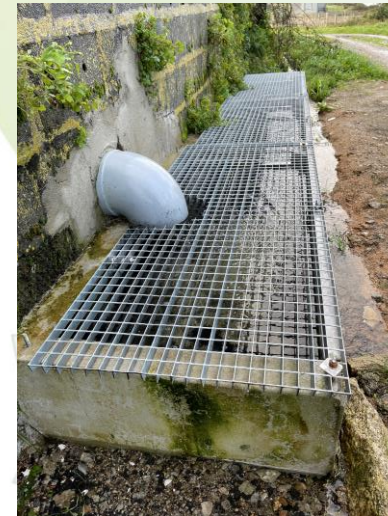
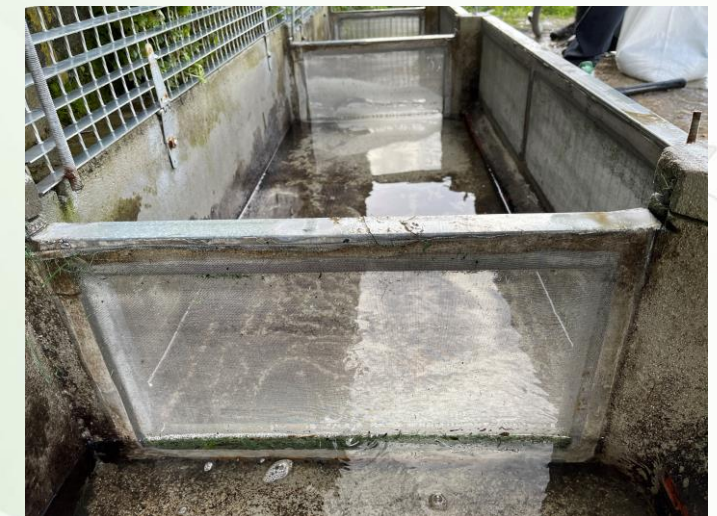
## **INCIDENT:** Identification of a new source of microplastics

Filters clogged in the drainage gutter manholes, mainly due to free fibres arising from the wear of the artificial turf.

Remove filters.  
The new design of the filter system in the general drainage is sufficient.

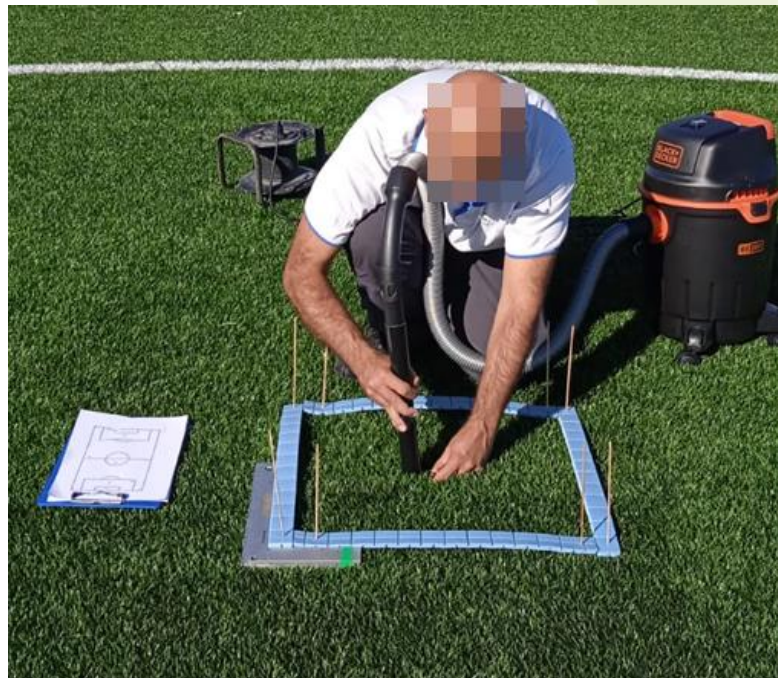
*Vacuuming of the infill material  
(rubber and sand) from a square area  
of 0.5 metres on each side*

*5 points distributed in the field  
according to EN 15330-1*

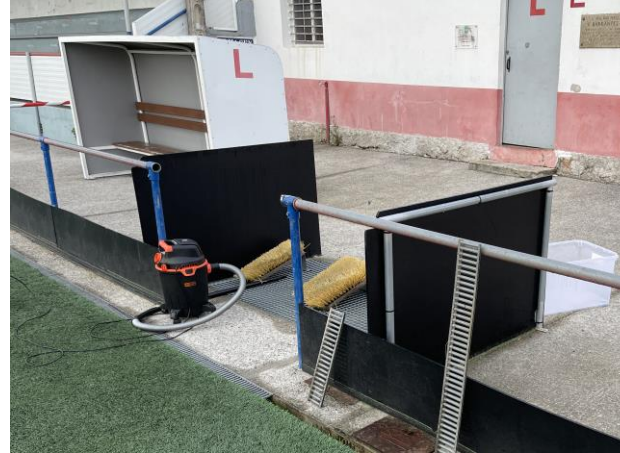
## *Brushing station*

- Quantification of rubber infill
- Quantification of artificial turf fibres
- Particle size distribution of rubber+sand
- Particle size distribution of artificial turf fibres

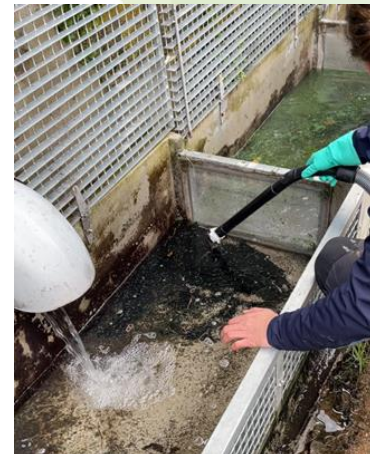
## *Filter system in the general drainage manifold*

- Quantification of rubber infill
- Quantification of artificial turf fibres
- Particle size distribution of rubber+sand
- Particle size distribution of artificial turf fibres

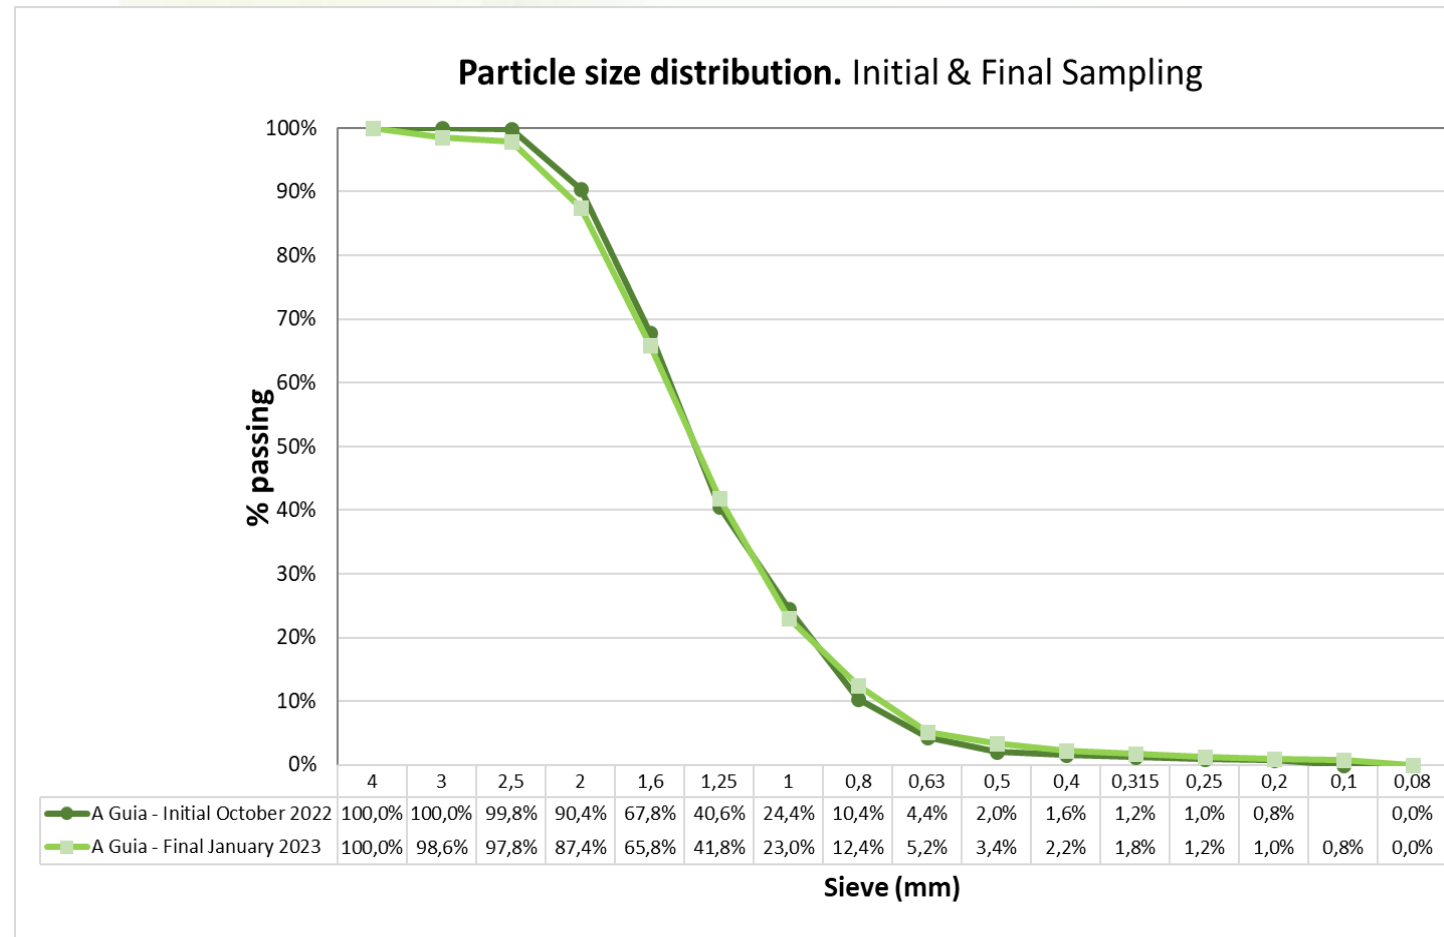
Particle size distribution of rubber infill particles present in the pitch:

- About 1.4% have a size below 0.2 mm.
- Only 0.8% have a size below 0.1 mm.
- No particles below 0.08 mm are detected.

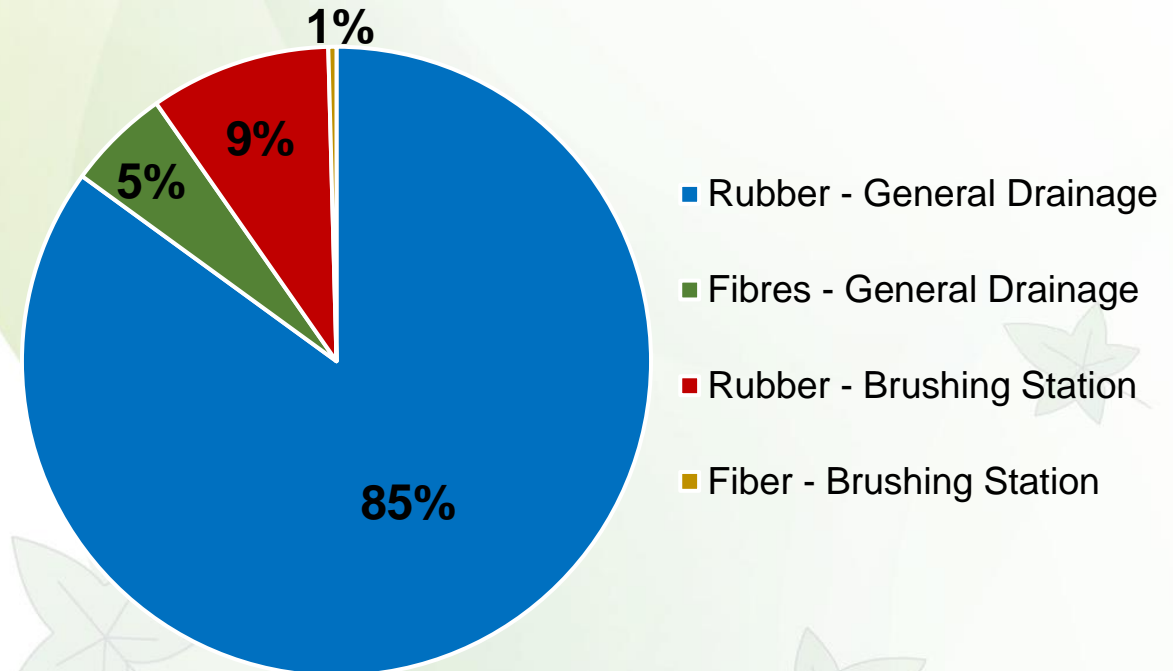
**Total Retained Microplastics in the RMM  
(October 2022 – January 2023)**

Source of Microplastics	Monitoring period (102 days)		Total (kg/year)	Per m <sup>2</sup> (g/m <sup>2</sup> /year)
	kg	%		
<b>RUBBER</b>	38.4	94	137.3	24
<b>ARTIFICIAL TURF FIBRES</b>	2.3	6	8.3	1.5

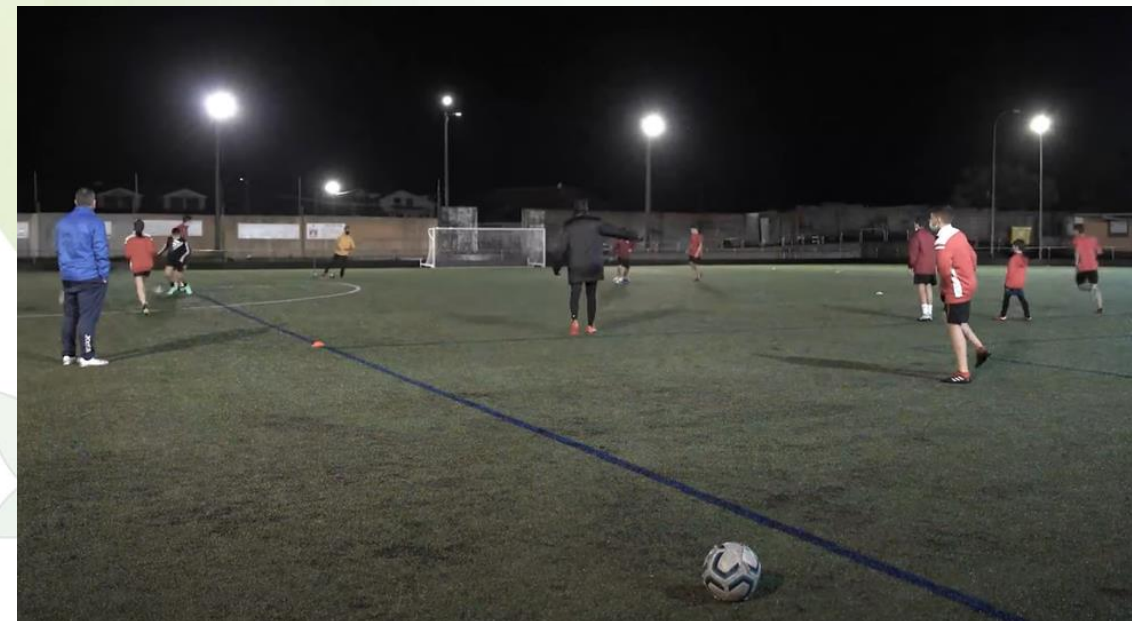
### Two monitored training sessions:

- Dry conditions (irrigation water)
- Wet conditions (rain)

### Two sample points:

- Brushing Station: retained
- Boots and clothing: released by players

Dry Conditions Training	Wet Conditions Training
Duration (minutes)	45	90
Players' description	8 children 8-10 y/o 1 coach	20 children 8 - 11 y/o 8 children 5 - 8 y/o 16 children 4 - 5 y/o 4 coaches
<b>Number of players</b> Total in training	9	44
Monitoring boots and clothing	8	22

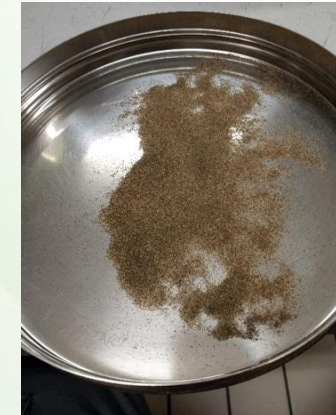
Sieve 0.125 mm

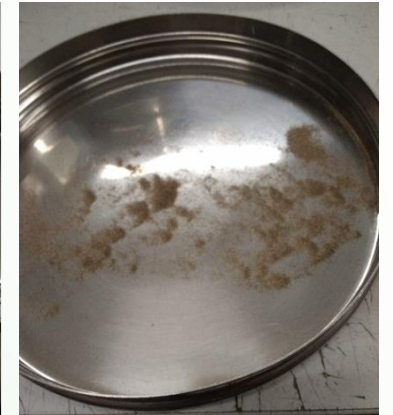
Sieve 0.063 mm

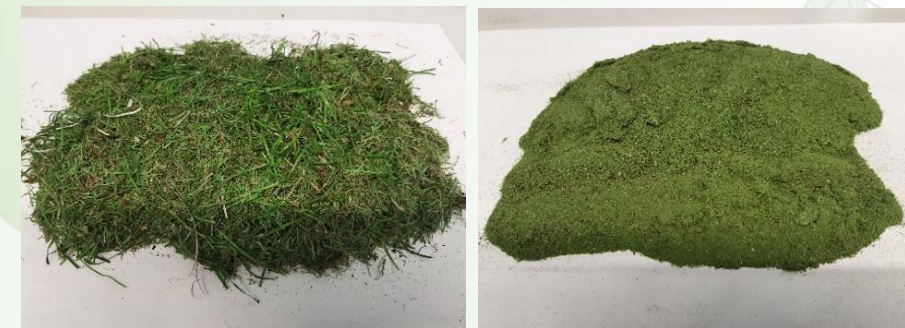
Sample of artificial turf fibres collected in the drainage gutter manholes in May 2022.

2. **New source of non-intentionally added microplastics from the wear of the artificial turf fibres.**
